AUTODATA TECHNICAL

Q A customer of ours has a 2011 Audi A6 with a rattling noise from the fascia area when driving above 20 mph (35 kph). The rattling noise sounds as though it is coming from the RH side of the fascia, but it can be difficult to pin-point. Have you come across this rattling noise before?

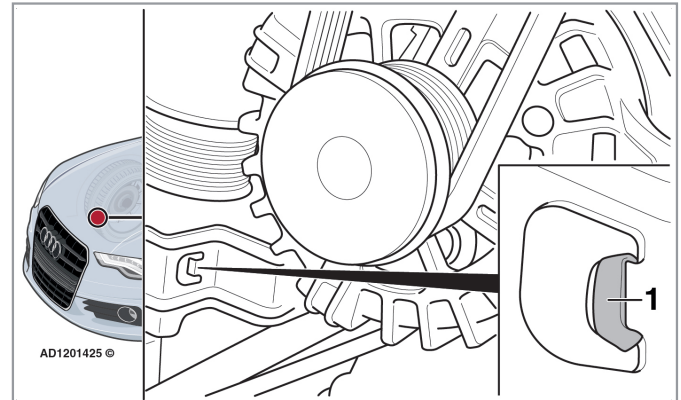
A Yes, the rattling noise you describe could be due to excessive free play between the starter motor wiring harness bracket lug and the aperture in the chassis leg. Detach the starter motor wiring harness bracket from the RH front chassis leg. Using fabric tape, available from Audi parts department, wrap the fabric tape around the lug for the starter motor wiring harness bracket 4 times (fig. 1.1). Refit the starter motor wiring harness bracket to the chassis leg. Ensure a tight fit between the starter motor wiring harness bracket lug and aperture in the chassis leg. Carry out a road test to confirm the rattling noise has been eliminated.
