## AUTODATA TECHNICAL

**Q** A customer's 2011 3 door Volkswagen Polo is making a knocking noise when closing the driver's door. We have removed the door trim panel and checked for anything that may be adrift but nothing seems to be out of position. Can you help?

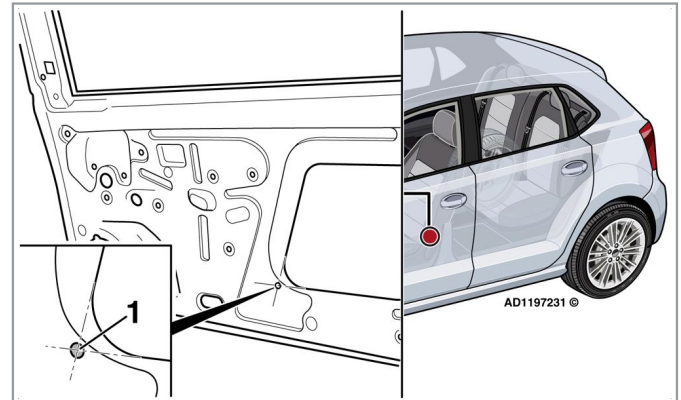
**A** The knocking noise you describe has been reported to us before on 3 door Polo models 2009-12 (VIN up to 186061) with electric windows. The noise is due to the window winder mechanism drive cable knocking against the inside of the door upon closing.

Remove the door trim panel. Use a 6,5 mm drill to make a hole in the door positioned as shown (fig. 1.1). Secure the window winder mechanism drive cable to the inside of the door with a cable tie. Ensure cable tie is not too tight. Refit the door trim panel. Operate the door to ensure the fault has been rectified. Repeat the procedure for the opposite side.
