**A 2007 Suzuki Swift we look after is suffering an electrical problem of intermittent loss of central locking, electric windows and hazard warning lamps. We have carried out wiring tests and checked earth points for loose or corroded connections but have not found the cause of the fault. Is this a known fault?**

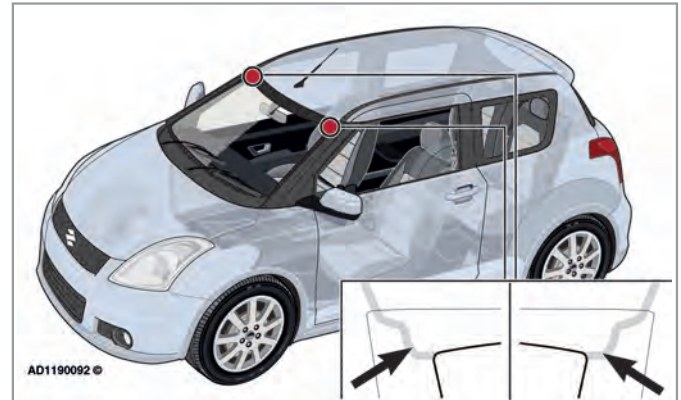
Yes, other Suzuki Swift owners have reported this fault and it is due to water ingress into the multifunction control module through a bodywork joint in the A-post.

Carry out a water test to the A-post area to confirm the fault. If the fault is present, remove the windscreen. Apply sealant to the bodywork joint in the affected area (Fig 1). Refit the windscreen. Replace the multifunction control if necessary. Erase any related trouble codes. Check the electrical components mentioned function correctly to confirm the fault is fixed.
