AUTODATA TECHNICAL

Autodata, UK supplier of technical information to the automotive aftermarket, shares fixes and problems raised through its technical helpline, available to all UK customers.

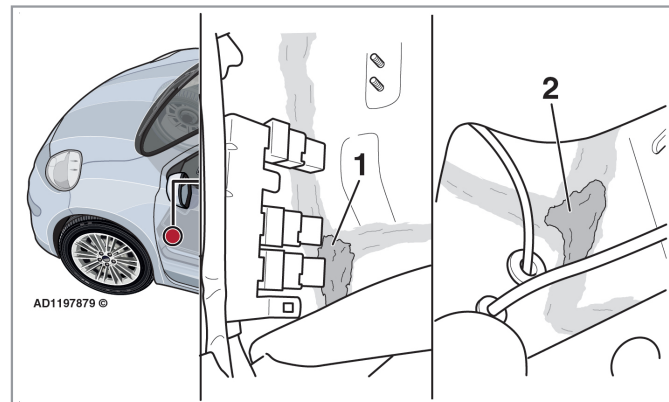
Q We are having trouble diagnosing a water ingress on a 2011 Nissan Micra. The front footwell carpets are wet after heavy rain. We have carried out several water tests but cannot see how the water is entering the vehicle. Have you got any advice for us?

A Yes, we are aware of this fault and the cause is water ingress through the bulkhead bodywork joints due to insufficient quantity of sealant.

Remove the side trim panels in RH and LH footwells. Inspect the bodywork joint in LH footwell. Apply sealant to bodywork joint in the affected area (Fig 1.1). Inspect the bodywork joint in RH footwell. Apply sealant to bodywork joint in the affected area (Fig 1.2). Dry out carpets as necessary.
